CHERRY PIE (Gary & Ruth)

A short story about our problem with our: SWIFT 18 KEEL MECHANISM

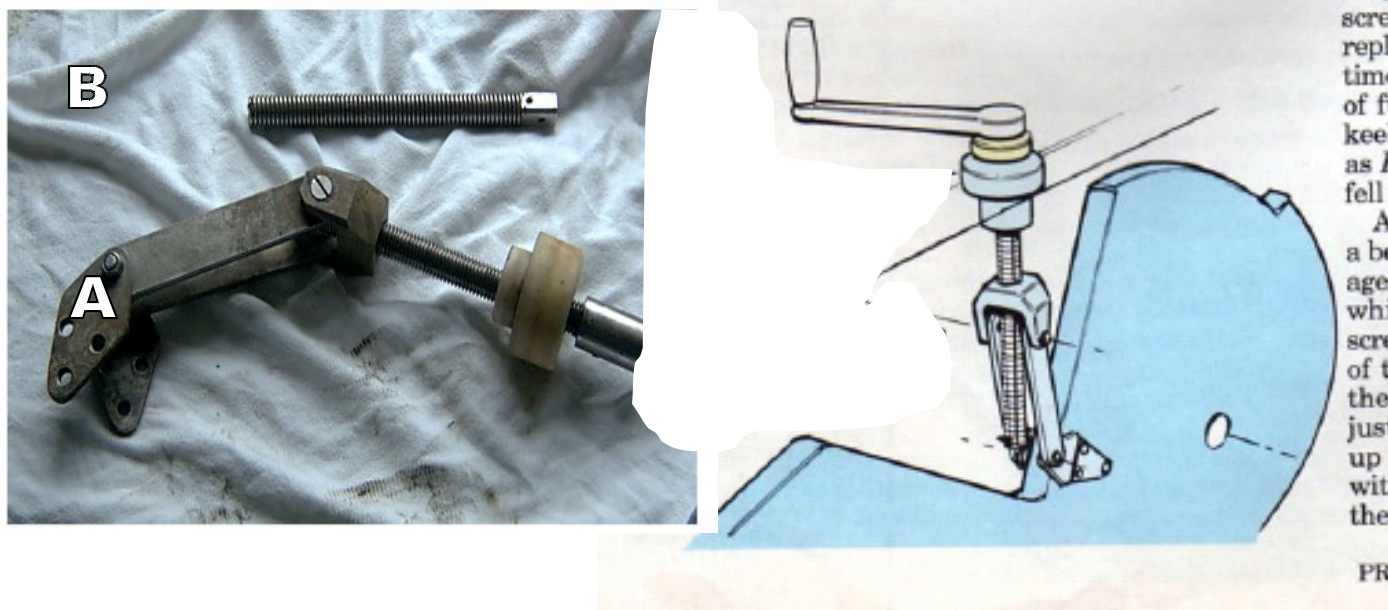
Pictured above in the photo A is our keel mechanism, last Monday 21/08/06 just after returning from a short sail double reefed in the Conwy Bay area the sails were stowed away and the keel retracted. The keel mechanism felt unusually stiff so rather than beaching for a short time and greasing the screw we decided to lower the keel onto a warp suspended below and cleated amidships. On lowering the keel a metallic ripping sound was heard and then a bang.....the bush had stripped and the keel even missed the warp (not in the right position). Having got over the shock we decided that was the end of our season unless we could get Cherry Pie home and repaired quickly.

We have been quoted £80 for a new screw and bush. The screw B (pictured) is the original that was bent in 1994 (48 turns) and replaced with A (68 turns) we have asked for a new screw to be made like the original because we think that the mechanism was weakened by having more thread. We also discussed the possibility of using stainless steel for the bush, thinking this would be stronger, however we were advised against this because the bronze bush acts as the weakest link so to speak and would save against more serious damage.... Hope you found this of interest. See photos of Cherry Pie jacked up in photos section.
