Repairing boats with Fibreglass Reinforced Plastics

a **Fibreglass**
Limited publication
in collaboration with
Tyler Boat Co. Ltd.

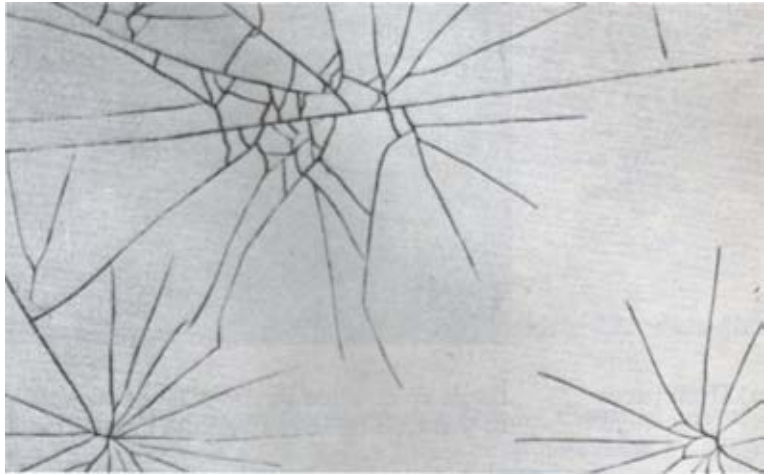
a) Hairline fractures

are cracks which are confined to the surface gel-coat and do not penetrate into the main laminate.

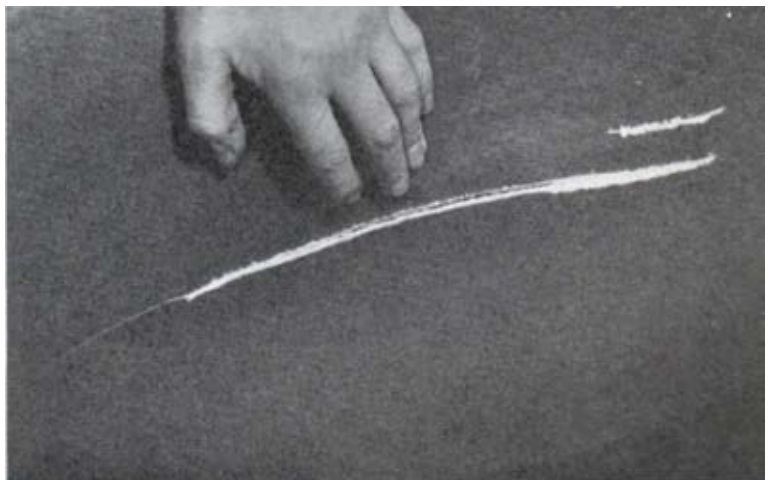
b) Grazes

are the result of abrasion rubbing off the gel-coat and exposing the Fibreglass reinforced laminate beneath.

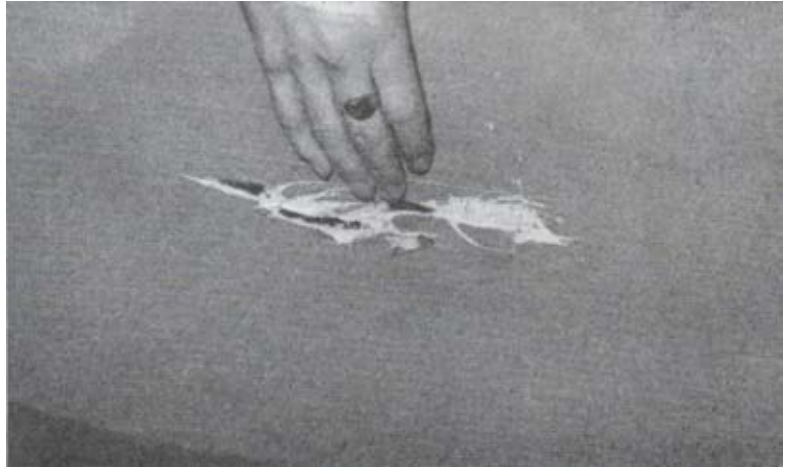
c) Impact fractures

are caused by a hard blow. In this case the laminate itself is crazed and damaged, although it is not completely penetrated.

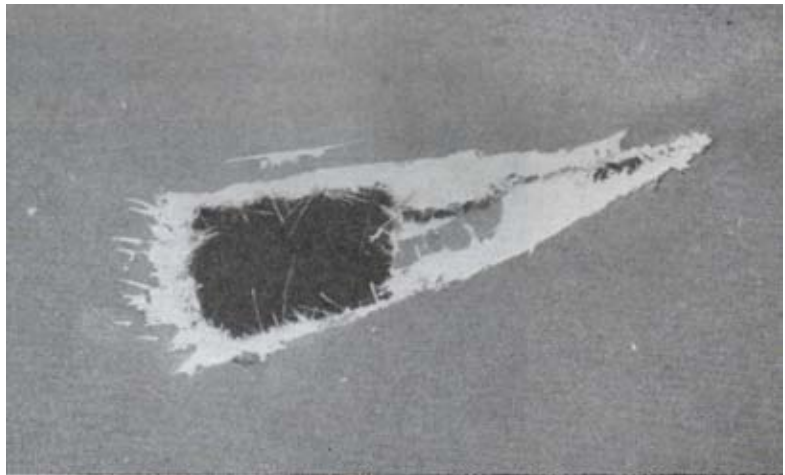
d) Punctures

result from a harder blow or impact with a pointed object and in this case there is a definite hole through the laminate.

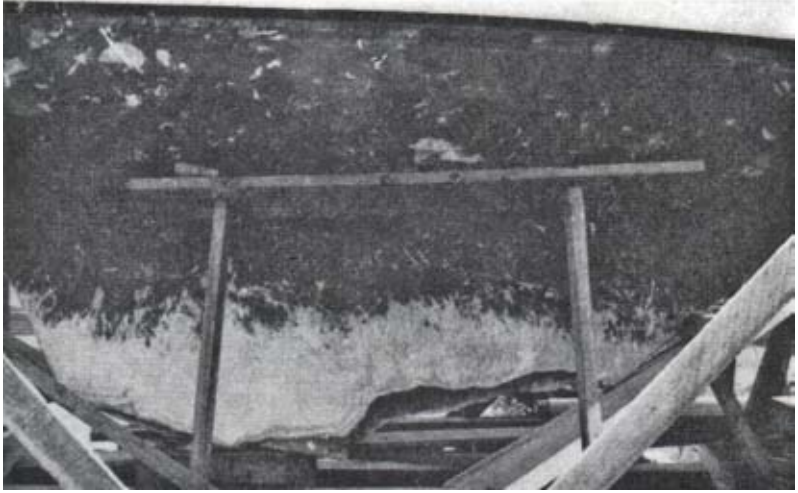
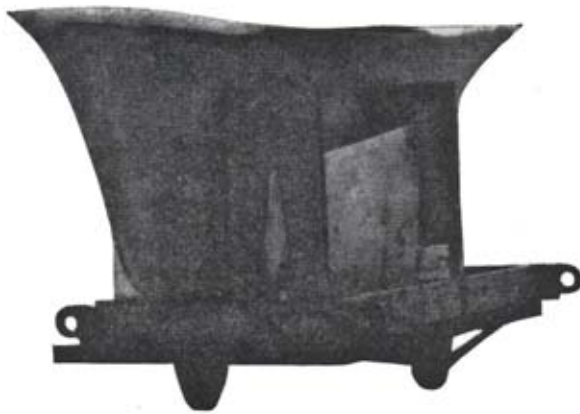
A repair example

During a storm in the West Indies, `Merlin' went aground on a reef and for 18 hours was pounded unmercifully. Once the storm had abated the yacht was refloated and sailed 3 miles to a safe anchorage. From there `Merlin', with full rig, was towed 40 miles back to base in a fairly rough beam sea. When describing the incident the owner remarked on the surprising stability of the damaged boat when in tow.

Inspection revealed that damage was mainly confined to the keel, but through continuous pounding on the reef this was indeed extensive. A large section has been worn and gouged away and, in consequence, most of the bonded-in ballast had been lost; of the original total of 2 tons 15 cwts under 1 ton remained. The owner suggests that it was this loss of ballast which made the boat light enough to float off the reef as the gale died down and it was probably the bonded-in petrol and water tanks which gave

sufficient buoyancy for this to happen. The rudder plate was also damaged beyond repair, but had remained in place and was used for steering the boat home.

Once the Insurance Company had given the go-ahead the Tyler Boat Co. manufactured a completely new keel section in Fibreglass Reinforced Plastics, bonding-in the ballast and tacking into their correct positions a new set of tanks. A new rudder was also moulded and this, together with the keel and all the necessary materials and equipment for attachment and a kit of tools, was shipped out to the West Indies within a few days.

Once the keel had arrived one of Tyler's Technical Supervisors flew out to supervise the repair and work on the installation of the new keel. By the time he arrived most of the interior fittings in way of damaged keel area, including the engine installation, had been removed by a local yard.
