Repairing boats with Fibreglass Reinforced Plastics

a **Fibreglass**
Limited publication
in collaboration with
Tyler Boat Co. Ltd.

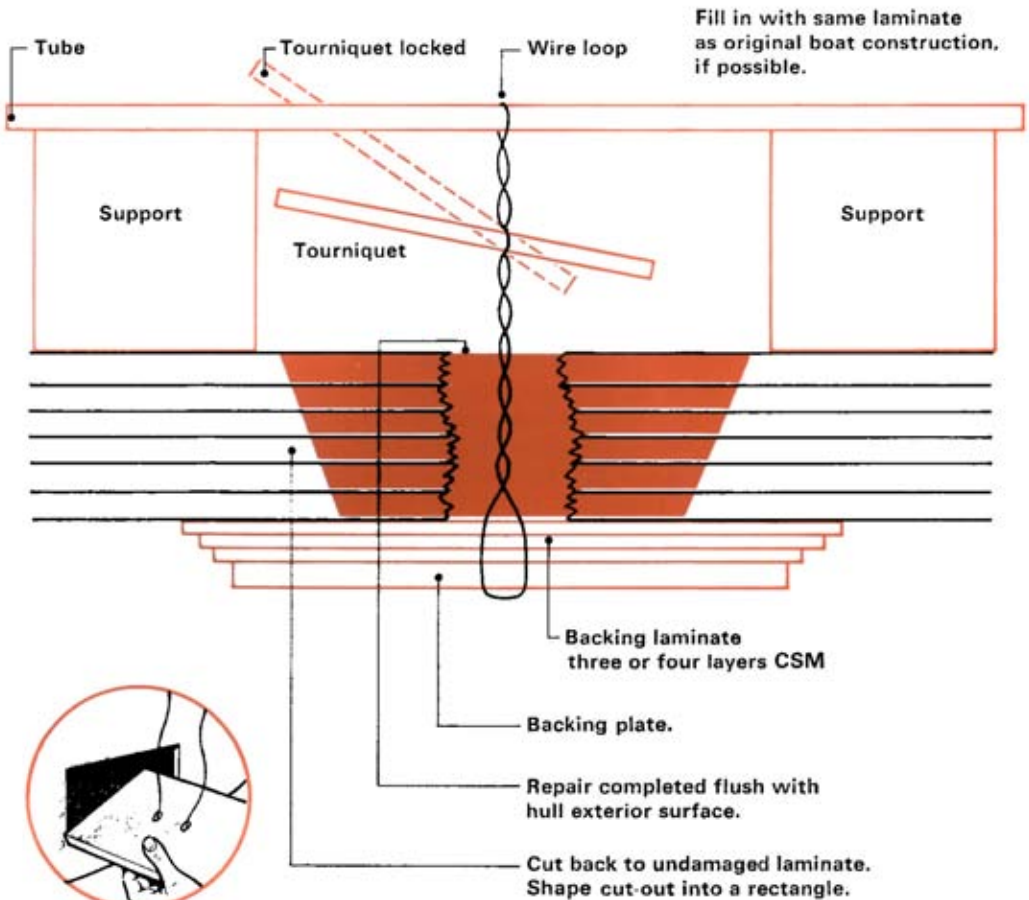
Repairing a blind panel

(a) In many boats it is impossible to reach the inner face of the hull in certain areas. When damage of the impact fracture or puncture type takes place in such a location a special repair technique has to be employed.

(b) The extent of the damage is first determined and a rectangular hole is then cut which removes any damaged laminate completely.
